## Reflective Cracking Testing Notes

**Date:** February 19, 2015

**Project:** Reflective Cracking Indoor Phase IV

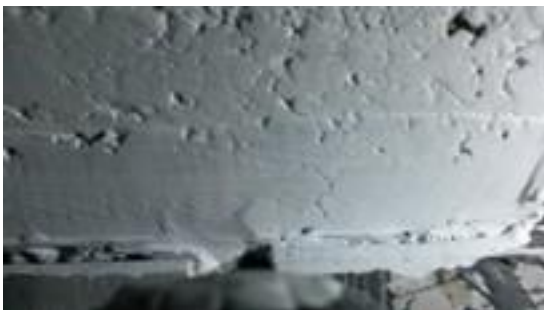
The 12 mil formal test continued on the Phase IV test item. On the South test section, the inner vertical edge remains unchanged from the pre-test condition, as shown in Figure 1 below. The South outer vertical edge shows no cracks, as shown in Figure 2. On the North test section, the inner vertical edge remains unchanged from the pre-test condition, as shown in Figure 3. The North outer vertical edge shows the first sign of a crack through SG6-N-0 and stops just above the sensor, 1 inch from the bottom, as shown in Figure 4. The sensor is still responding, as shown in Figure 5 below.

Figure 1. South Inner Vertical Edge.

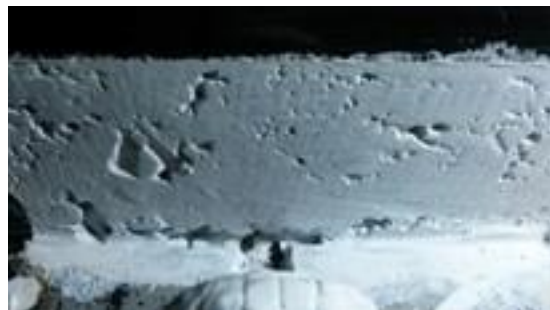
Figure 2. South Outer Vertical Edge.

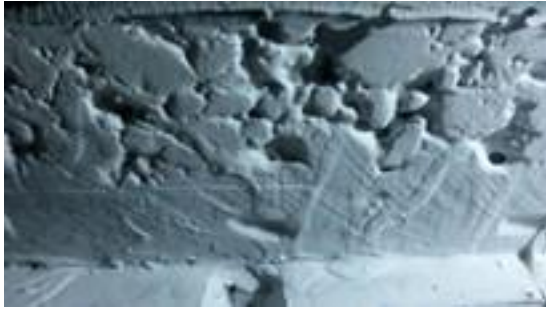
Figure 3. North Inner Vertical Edge.

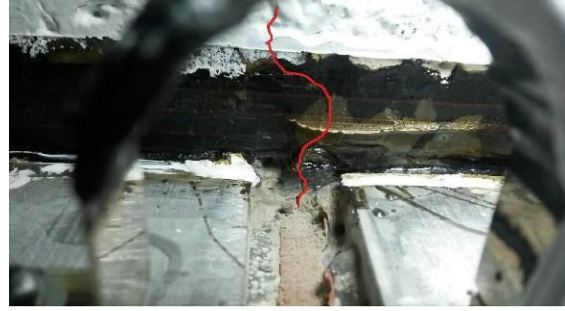
Figure 4. North Outer Vertical Edge.

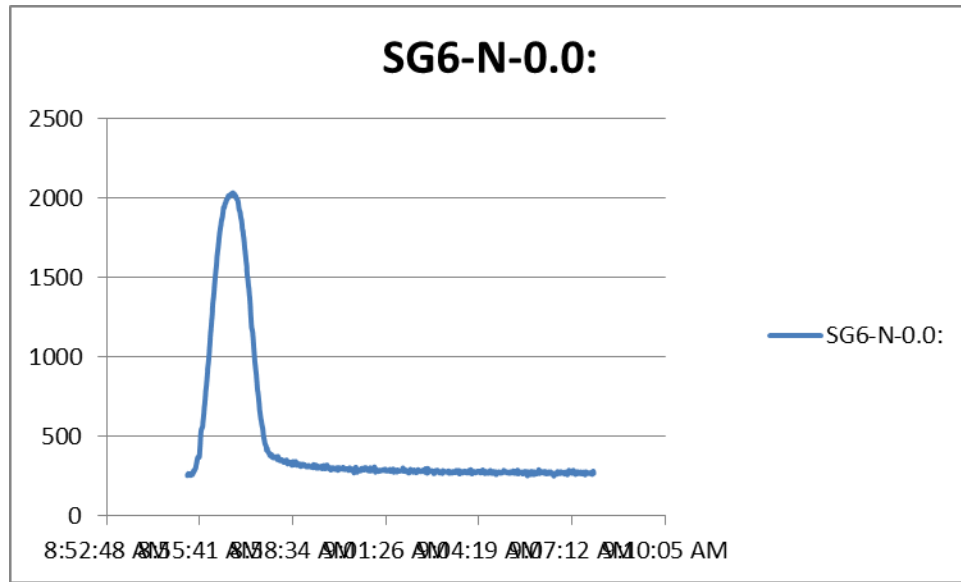
Figure 5. North Outer Vertical Edge (SG6-N-0) Response Curve.
